The company

4 Desserts processing is carried out in a two storey building of reinforced concrete frame construction with brick cavity wall and window in-filling. The explosion occurred in the south east corner of the first floor where the basic ingredient, corn starch, was conveyed to four custard powder manufacturing lines.

Explosion

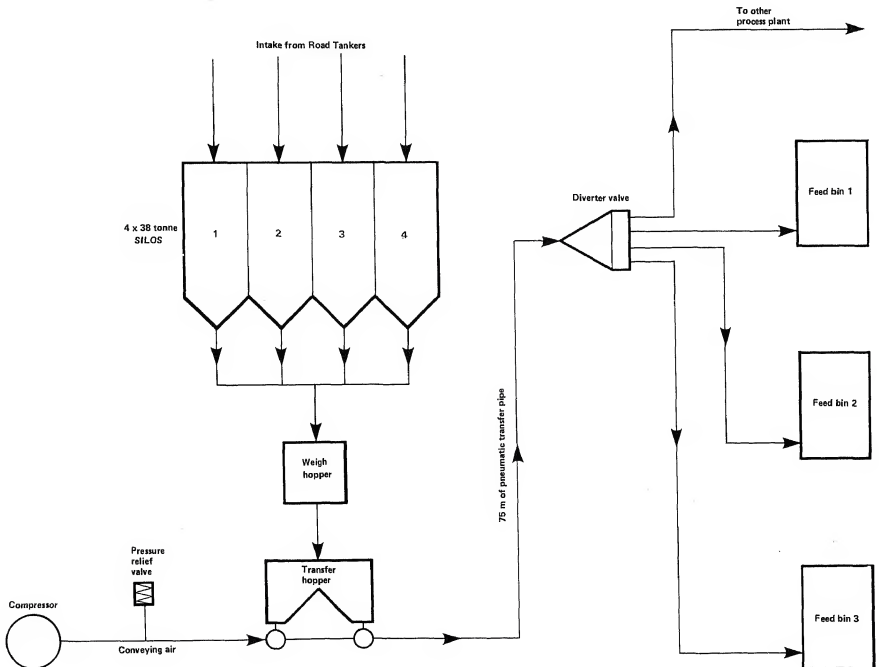
Fig 1 Process flow diagram

8 Corn starch was delivered to the factory daily by road tankers. These were discharged pneumatically into bulk storage silos from which it was drawn off as required through a weigh hopper into a transfer hopper. The base of this hopper was in the form of two inverted cones fitted with rotary feeder valves. Corn starch was transferred from the hopper bottom through these valves and conveyed pneumatically by a system operating at $48-69 \text{ KN/m}^2$ ($7-10 \text{ lbf/in}^2$) through a transfer pipe to the processing area. The transfer pipe ran some 75 m at high level through the factory. The conveying air was supplied by an air compressor. To prevent over-pressurisation of the compressor it was protected by a pressure relief valve (see Fig 1).

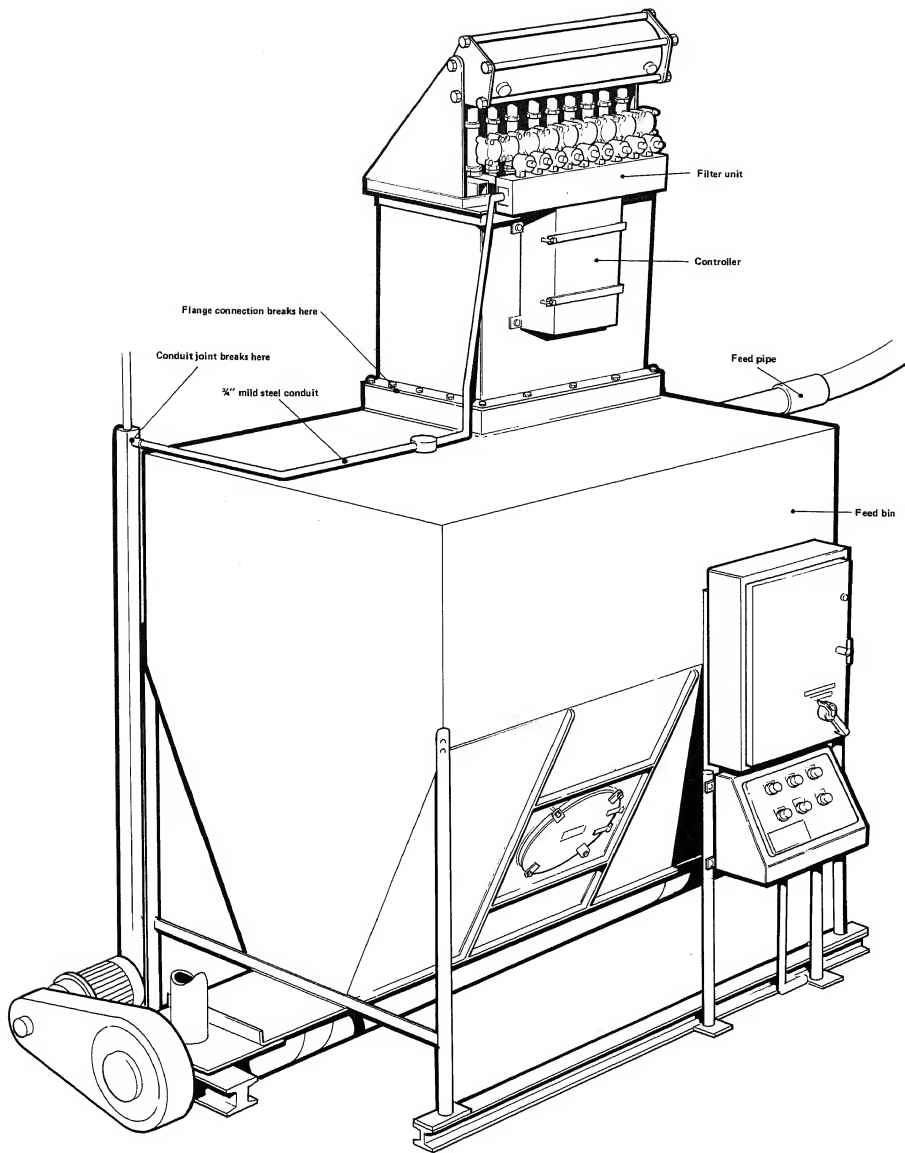
Fig 2 Feed bin and filter unit

10 On top of each feed bin there was a filter unit which was connected to the bin by a rectangular bolted flange (see Fig 2). The purpose of the filter unit was to remove corn starch from the conveying air stream which was vented into the workroom through the filter discharge. The individual fabric filter socks in each unit were provided with automatic reverse air flow cleaning and for this there was a separate compressed air supply to each unit. Each filter sock in a unit was cleaned in sequence when the compressed air supply was operated by solenoid operated valves in the filter control unit. There was a 220V AC electrical supply to each unit which was routed via a vertical trunking at the side of each feed bin and then by conduit across the bin top.

41 Failure occurred at the rectangular flange connection between the filter unit and the hopper top. There was clear evidence of a variety of damage to the retaining bolts.

- (d) the feed bins have also been fitted with explosion relief panels, again venting safely outside the building;
- (e) improved dust filter units, incorporating explosion relief panels, have been fitted to the feed bins;

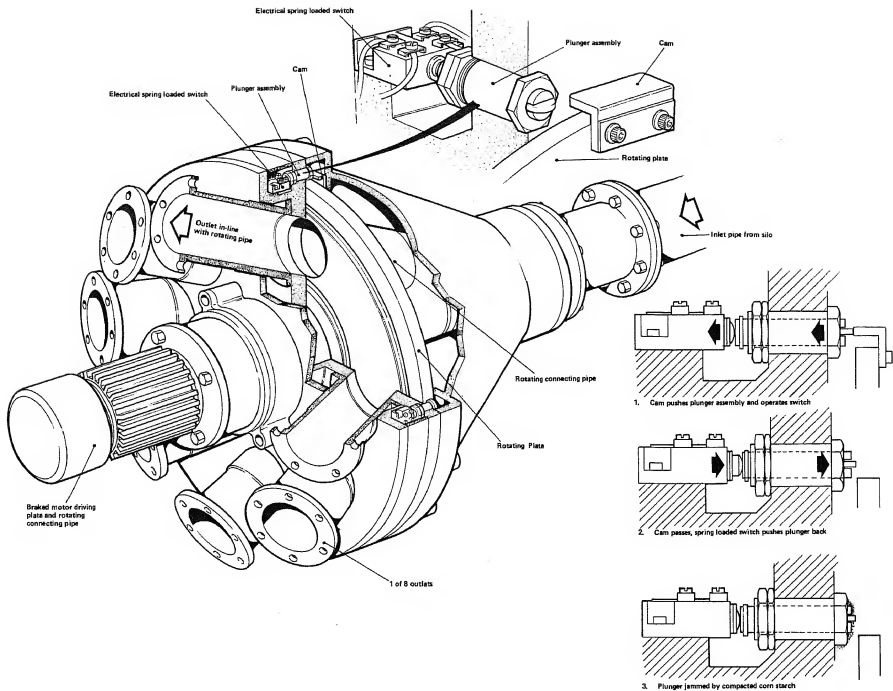
Fig 3 Diverter valve

12 The valve (see Fig 3) consisted of one inlet port and eight outlets. The starch flow entered the valve through the inlet port and of the eight outlets three were connected to the three custard powder manufacturing lines, four were blanked off and a further port was available to supply other plant. Material flow through the valve, from the inlet to a given outlet, was through an internal connecting pipe, one end of which was linked to the inlet and the other attached to a circular plate. This plate, and hence the connecting pipe, was rotated by a small electric motor. External to the inner valve chamber there was an electrical switch at each outlet port

- (l) at No 2 port the switch was in the depressed position being held by the operating plunger. This plunger was found to be permanently held in the depressed position due to an accumulation of compacted corn starch inside the valve;

35 When the control room operator changed the selector from No 1 to No 2 the connecting pipe in the diverter valve did not move as the control system was already cancelled by No 2 actuating switch already being held in the depressed position by the accumulation of corn starch on its operating plunger. The electrical supply to the drive motor and brake release was already disconnected by No 2 switch and the connecting pipe stayed at No 1 port.

37 As the valve was at high level adjacent to the ceiling, access for maintenance purposes was difficult. There was evidence that the valve required frequent attention and that corn starch leakage tended to accumulate in the valve chamber. Significantly, No 2 position was at the bottom of the valve and could therefore be expected to be more prone to contamination with corn starch.

- (f) the multi-port diverter valve has been replaced by a series of two-way valves. The setting of these is displayed on the control room panel: in addition the control room operator can visually check by direct observation;

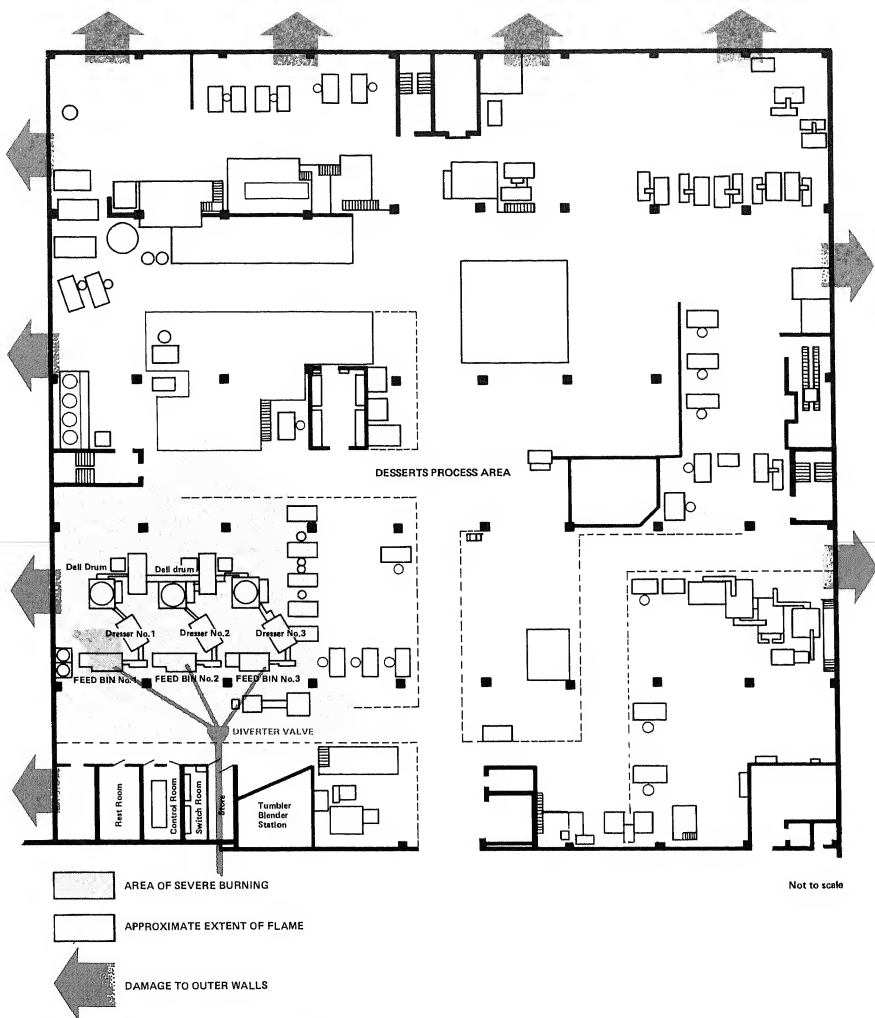
Fig 4 Plan showing damage to desserts processing area

21 Damage to the fabric of the building was substantial, but fortunately due to its position and the time when the incident occurred, there were no people about outside and no injuries were caused from falling masonry, or flying debris (see Fig 4).

22 Windows and brickwork were blown out on all four sides of the building with the south side receiving the most damage. Here brick and glass from heights between 6 m and 12 m were projected for horizontal distances of up to 8 m and 14 m, respectively. Small fragments of glass were thrown 20 to 30 m near the east end corridor.

25 On the process floor there was flame damage over an approximate area of 34 m by 22 m corresponding to about one fifth of the total floor area (see Fig 4). The limit of propagation was clearly indicated by scorched paper, plastic and wood. Further serious fire damage had been prevented by the operation of the automatic sprinkler system. The most severe burning occurred at high level (over 3 m) centred on No 1 feed bin.

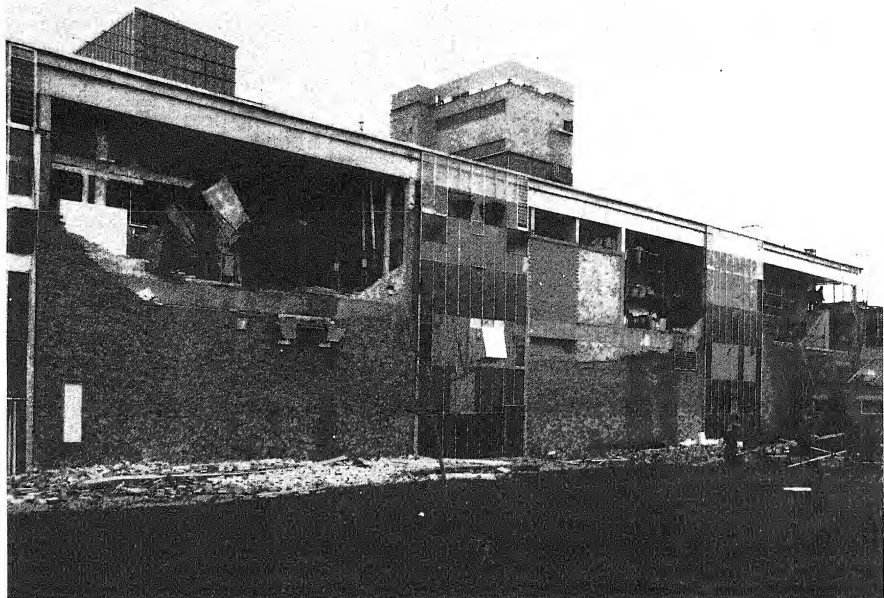
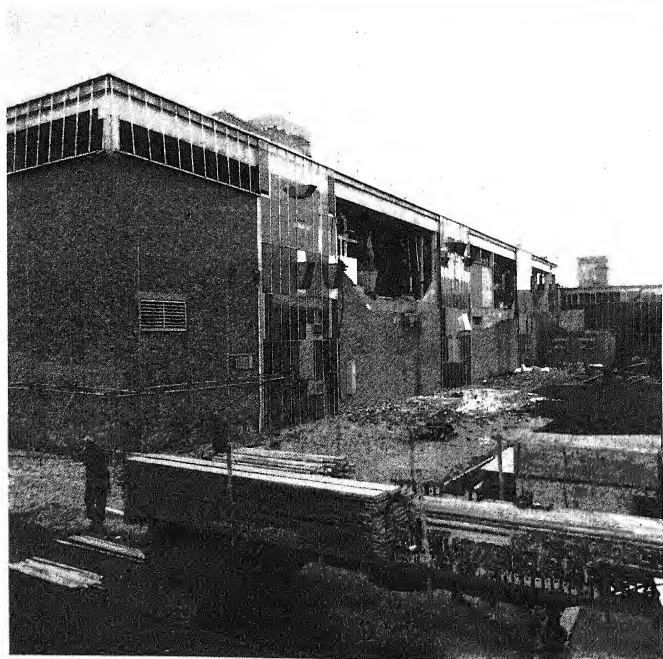
Fig 5 General views of damage to building

Diverter valve and flow control system

56 The company is incorporating explosion relief during the reconstruction and repair of the building walls.
